# How to defeat LED Ghosting on WPC Era Pins

## Analysis of the issue

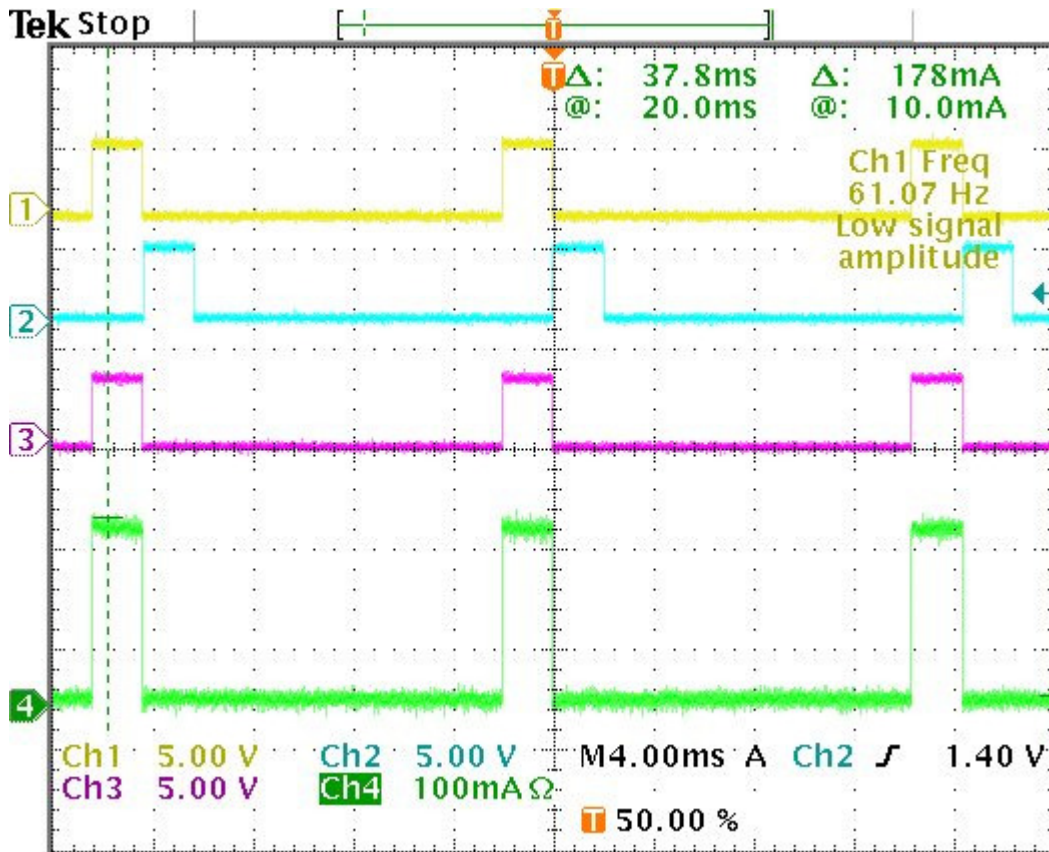
This capture shows two full 16mS cycles with Column 4 Row 1's lamp being lit.

Column 4 is driving approximately 180mA of current. During my testing no other rows are being lit so cointakers superbright led's draw an average of  $(180\text{mA} / 8) = 22.5\text{mA}$  when used in the lamp matrix.

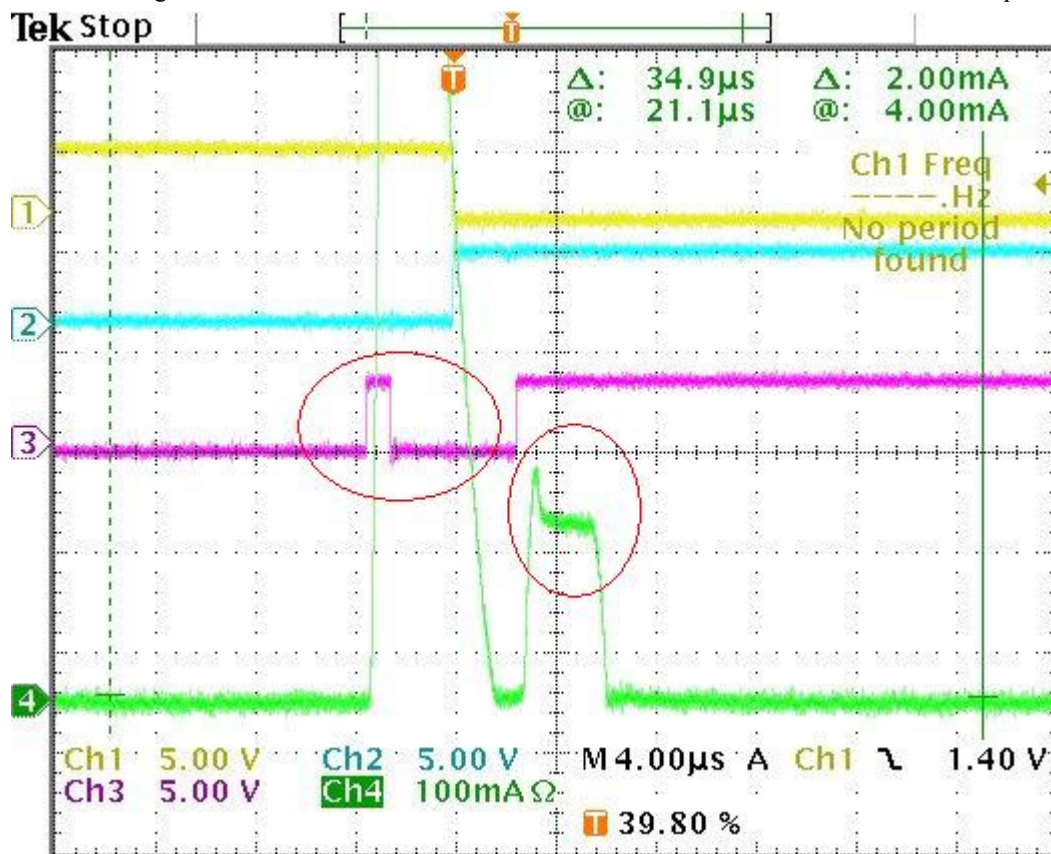
This capture shows the problem.

Here Column 5 & Row 1 is being turned on.

Note: The current spikes (Green) that occur on column 4. This is what causes Column 4 Row 1's LED to ghost when Column 5 Row 1's LED is turned on.

The first spike is massive. It peaks at over 2 Amps.

The 2nd current spike is about 180mA.

The second (180mA) current spike that occurs for column 4 is the problem that has been analyzed in the past. The driver is turning column 5 on at the same time it is turning column 4 off and then immediately turning the row on. Column 4's transistor takes a little while (in this example about 6µS) to actually turn off. So, when row 1 is turned on, column 4's transistor is still conducting allowing column 4 / row 1's LED to light.

I believe the first (left) current spike is due to an issue with the WPC ASIC.

The large column 4 current draw indicates that all 8 rows are being turned on. (ie: 0xFF is being latched into the row register)

I haven't actually connected an analyzer to these signals but you can tell from the above waveform and the code sequence that the ROW latching glitch occurs 6 cycles before the column is updated, which is in the middle of the CLR instruction. So, the CLR instruction appears to be causing the row data to be pre-maturely latched before the data bus is valid or the DREN signal is properly asserted to drive the correct data to the power/driver card.

The most likely cause of this bug is the CLR instruction is a 7 cycle operation where as the STA instruction is a 5 cycle operation and the ASIC doesn't properly handle bus cycles generated by the CLR instruction for generating the

DREN and/or LAMP\_ROW latch signals.

Basically, they eliminate use of the CLR instruction and write zeros to the row & column data earlier in the code to turn off the rows and column transistors. Also, when re-enabling the matrix they switch from writing the column first to writing the row first.

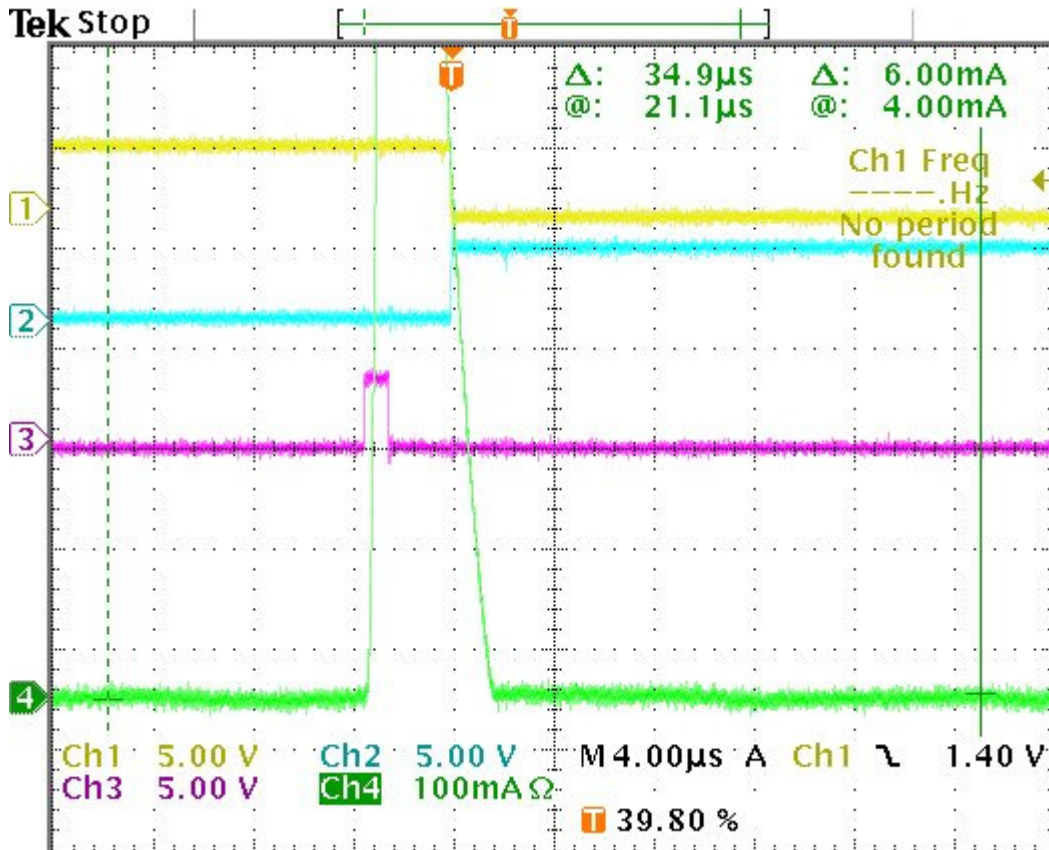
Here you can see the glitch during the CLR instruction occurs even when no lamps (rows) are being turned on.

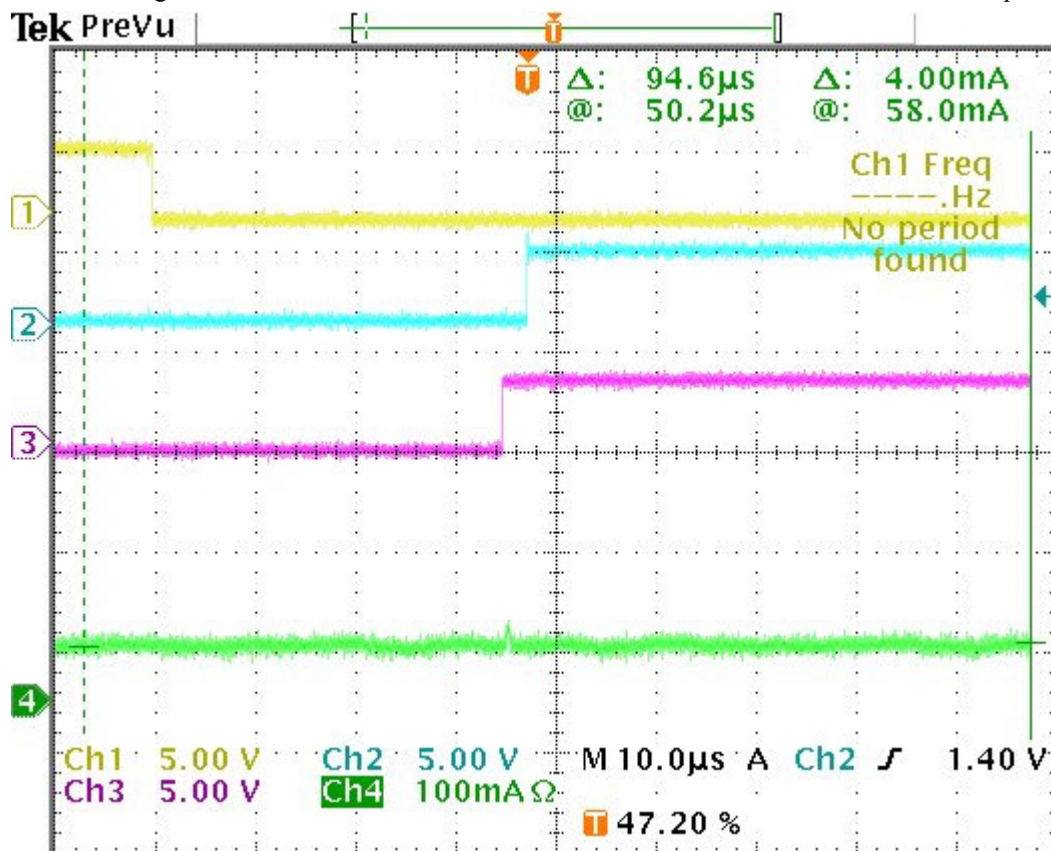
Here's a trace of the updated driver. Note how column 4 turns off about 37uS before column 5 turns on. Note how there are no current spikes for column 4 anywhere during this timeframe.
